RESERVE FUND STUDY
CLUB OCEAN VILLAS I
OCEAN CITY, MARYLAND 21842

CLUB OCEAN VILLAS BOARD OF DIRECTORS

CRITERIUM-HARBOR ENGINEERS
PO BOX 408
STEVENSON, MARYLAND 21153
410-363-4659
WWW.CRITERIUM-HARBOR.COM

APRIL 25, 2012

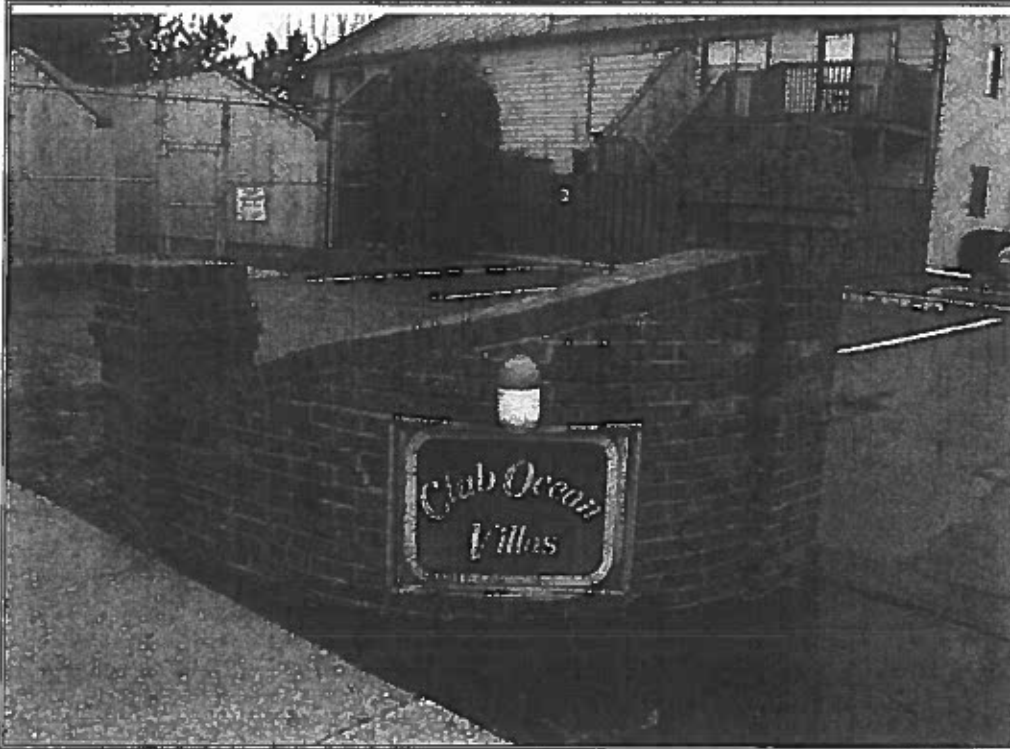
Photo Number
1

The brick monument sign on the left side of the entrance has some current damage and both wood signs which are mounted within the brick monuments are worn and in fair condition. We have included a cost estimate in the Reserve Tables for repair of the brick and replacement of the signs.

Description:
Brick entrance
monument with
wood signage

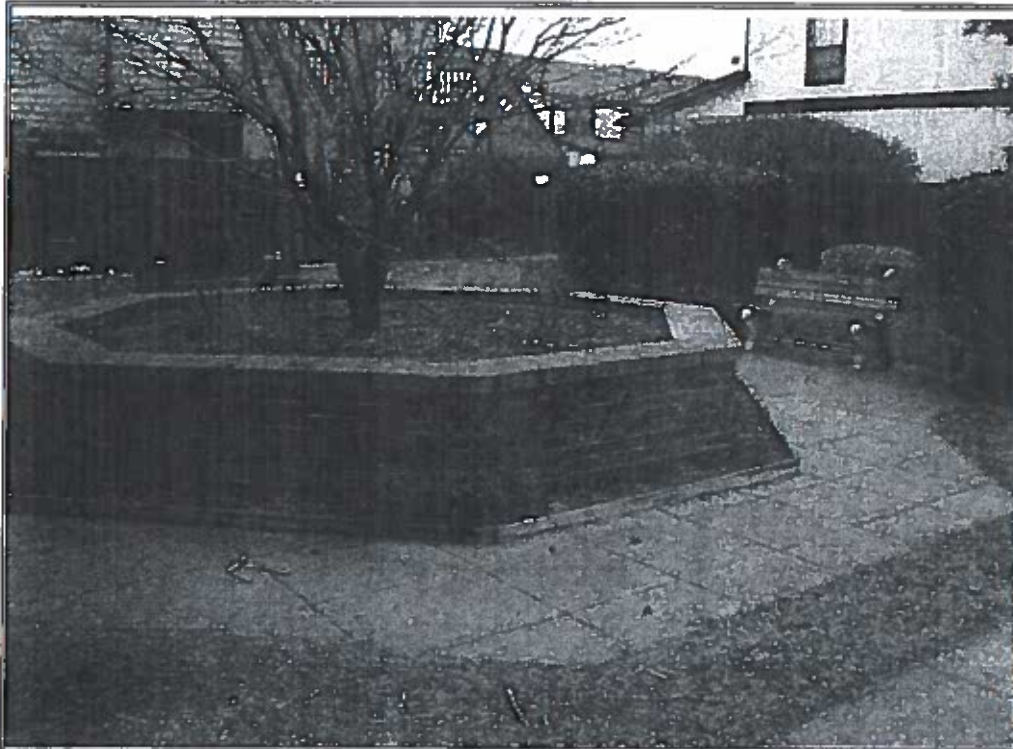
Photo Number
8

The site landscaping is generally in good condition. On-going maintenance of the plantings should be manageable on the annual maintenance and operations budget. In addition the brick planter is currently in need of some minor repairs and maintenance.

Description:
Brick planter and
benches

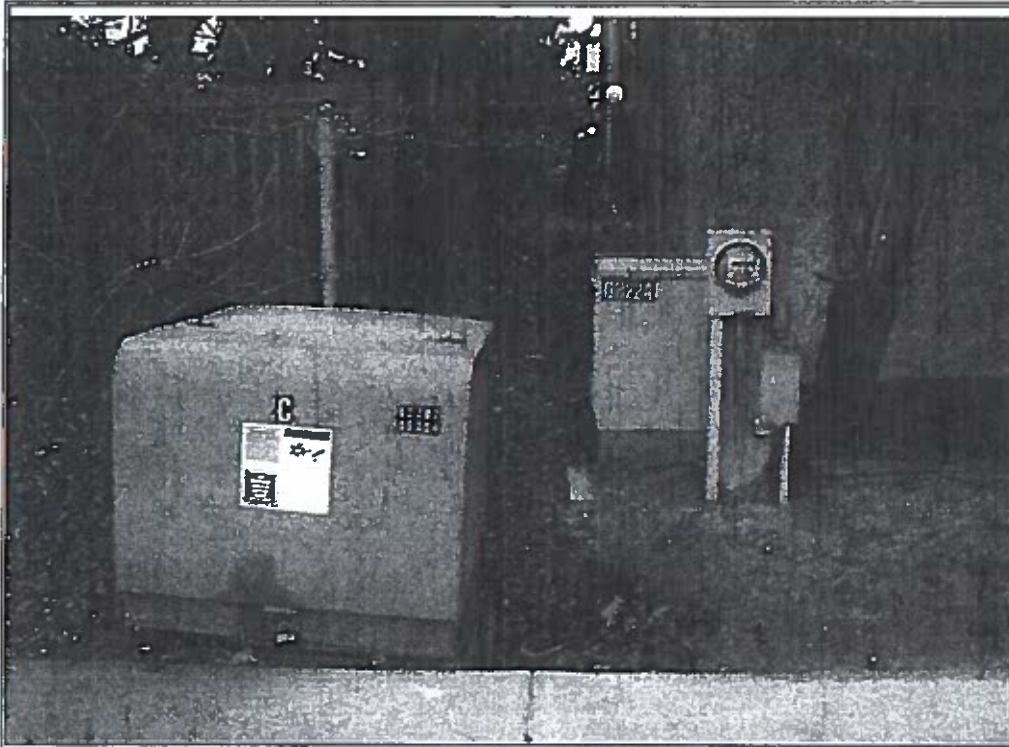
Photo Number
11

At the southwest corner of the property we observed an area of erosion near an electrical transformer and the public sidewalk at 120th Street. It appears that discharge from rainwater downspouts is directed along a path behind the buildings, toward 120th Street. Some modifications to the discharges will be required in order to prevent further erosion.

Description:
Area of erosion the
southwest corner
of the property

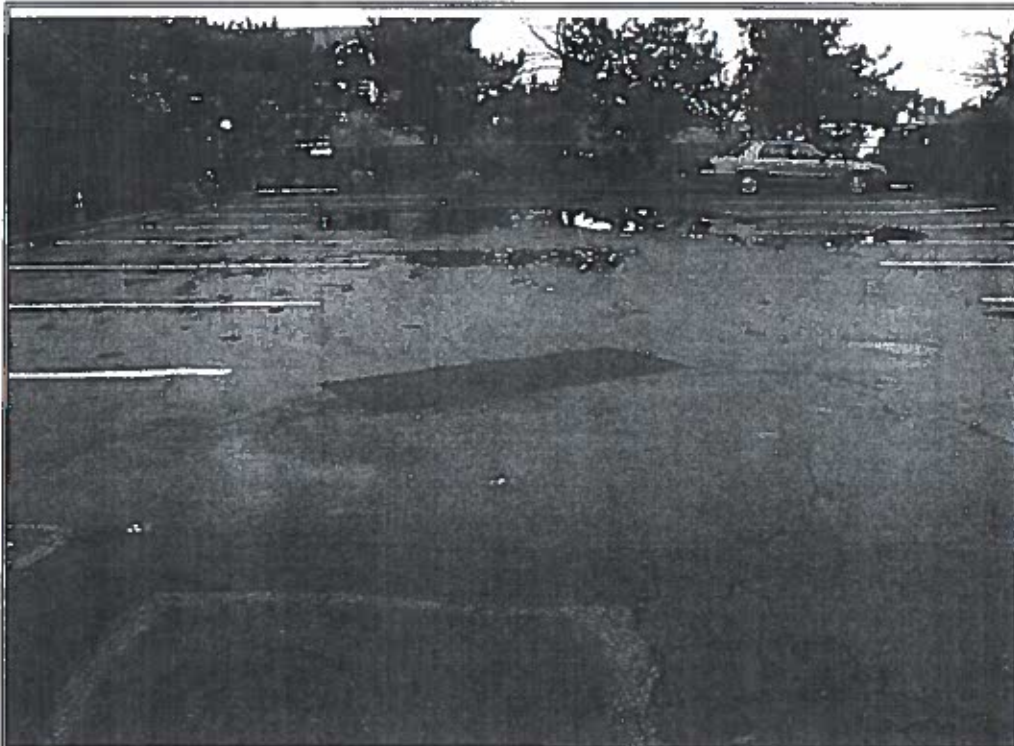
Photo Number
12

The first area of asphalt pavement on the west side of the community, between the first and second buildings, appears to be sloped away from the center drive aisle. We observed standing water in this area during our site inspection. This slope will have to be reworked with the next asphalt resurfacing work.

Description:
Area of ponding
due to lack of
proper slope in the
asphalt pavement

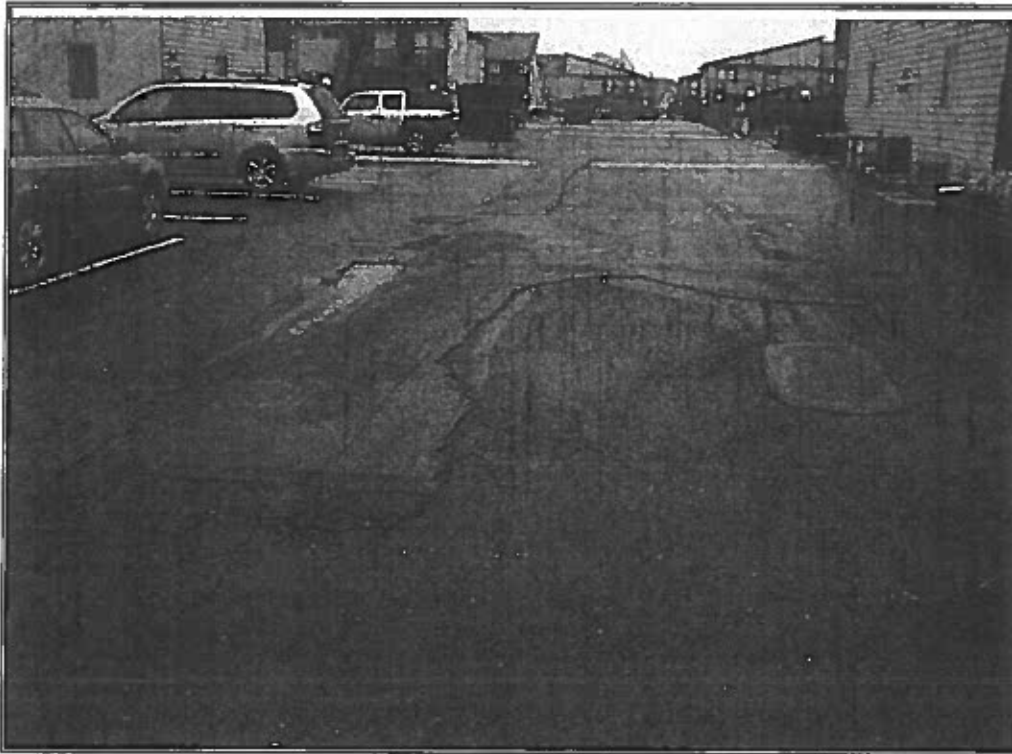
Photo Number
13

Based on our observations the asphalt pavements are in fair condition. We observed many areas of uneven surfaces due to settlement and patching. In addition some areas are not properly sloped for water drainage and significant areas of ponding were present at the time of our inspection.

Description:
Overview of
asphalt pavement
in the center drive
aisle with
settlement and
patching

We recommend that a resurfacing of the asphalt pavement be accomplished within the next few years in order to prevent additional deterioration to the entire pavement system, including the sub-surface. This resurfacing work should include re-sloping areas of poor drainage and some full depth repairs, particularly in the center drive aisle where it appears that continued settlement and patching has occurred. This work may also include the replacement of some of the concrete wheel stops.

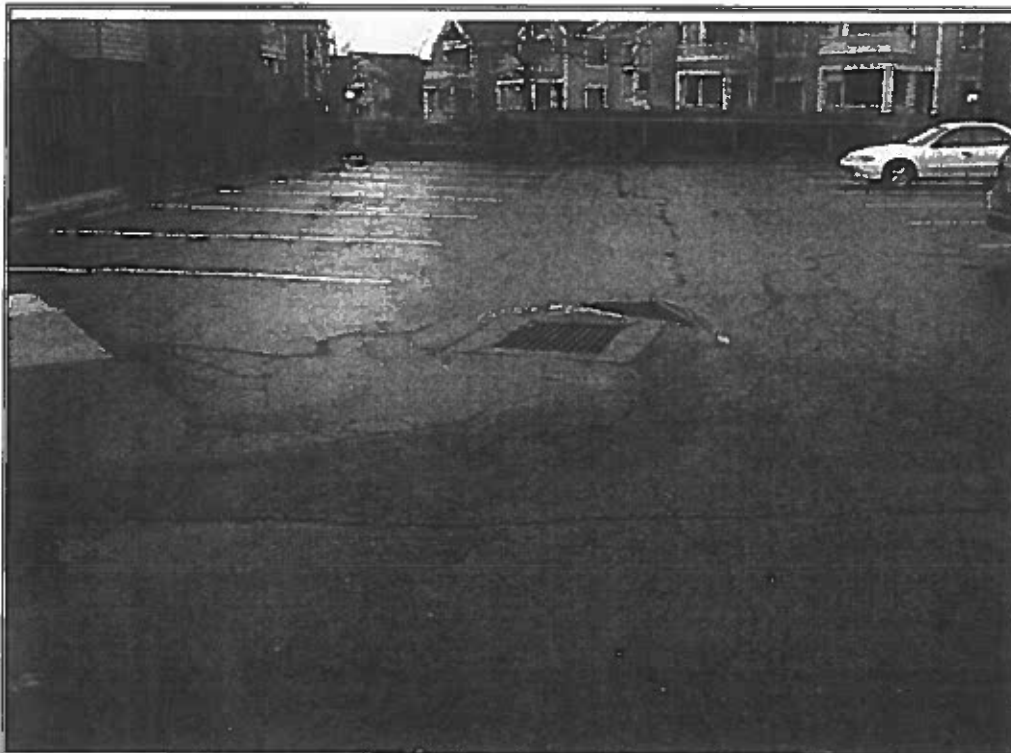
Photo Number
14

Description:
Cracking and some
ponding near the
area drain located
at the rear of the
site

In addition to the resurface work, we recommend the application of an oil resistant sealant be applied to all asphalt paved surfaces on a five-year cycle. Coincident with this work all cracks should be properly sealed and the parking stalls should be re-striped. We have included a periodic cost in the Reserve Table for this work.

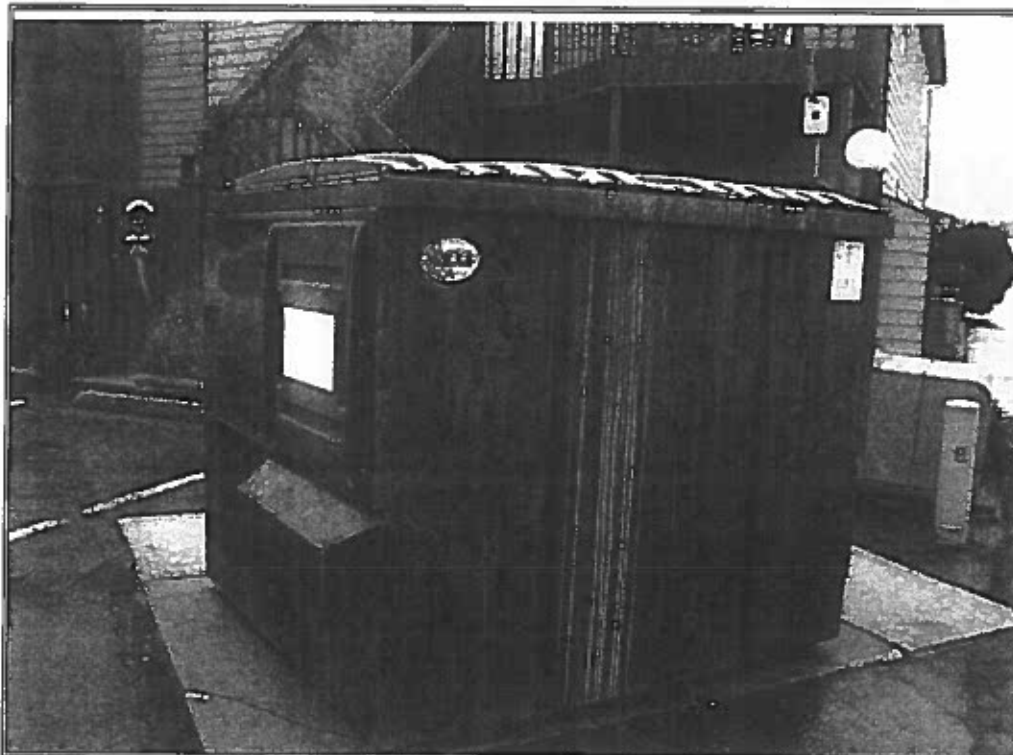
Photo Number
18

The trash containers are in good to fair condition with some rusting. We have included a cost estimate for their eventual replacement; however we recommend periodic scraping and painting with a rust inhibitive coating in order to prolong their useful lives.

Description:
Typical trash
dumpster placed
on a concrete pad
within the asphalt
pavement

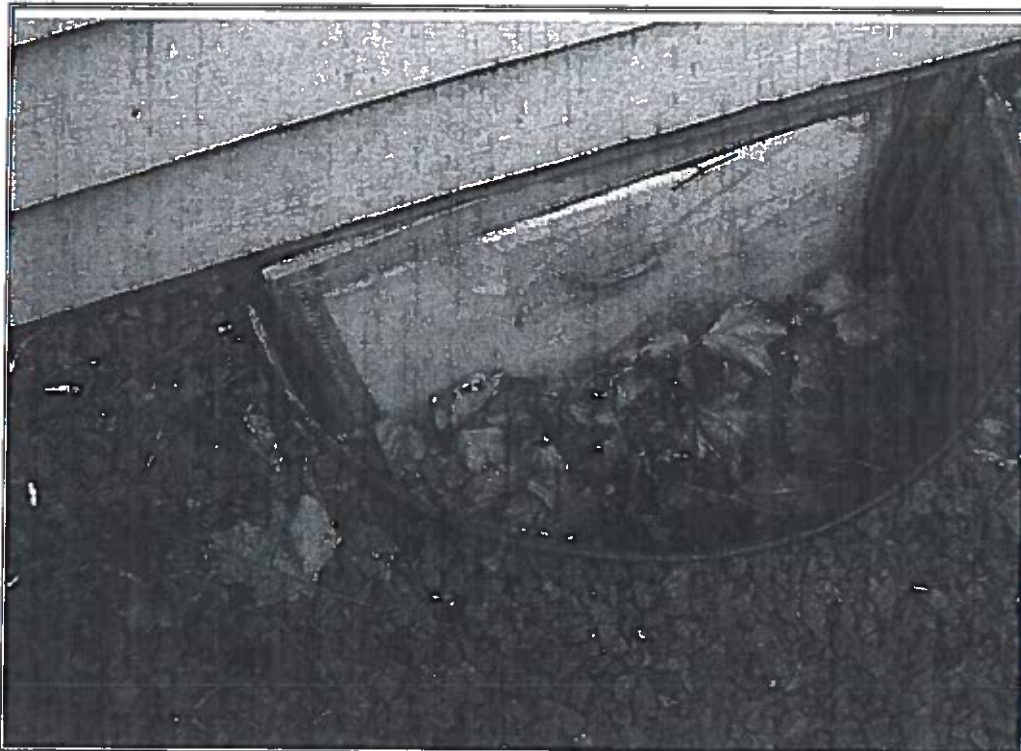
Photo Number
19

The crawl space window wells, access doors and vents are in good to fair condition we observed some of these components which are rusted and/or inoperable. We have included replacement cost estimates for these components in the Reserve Tables.

Description:
Typical crawlspace
access door with
window well

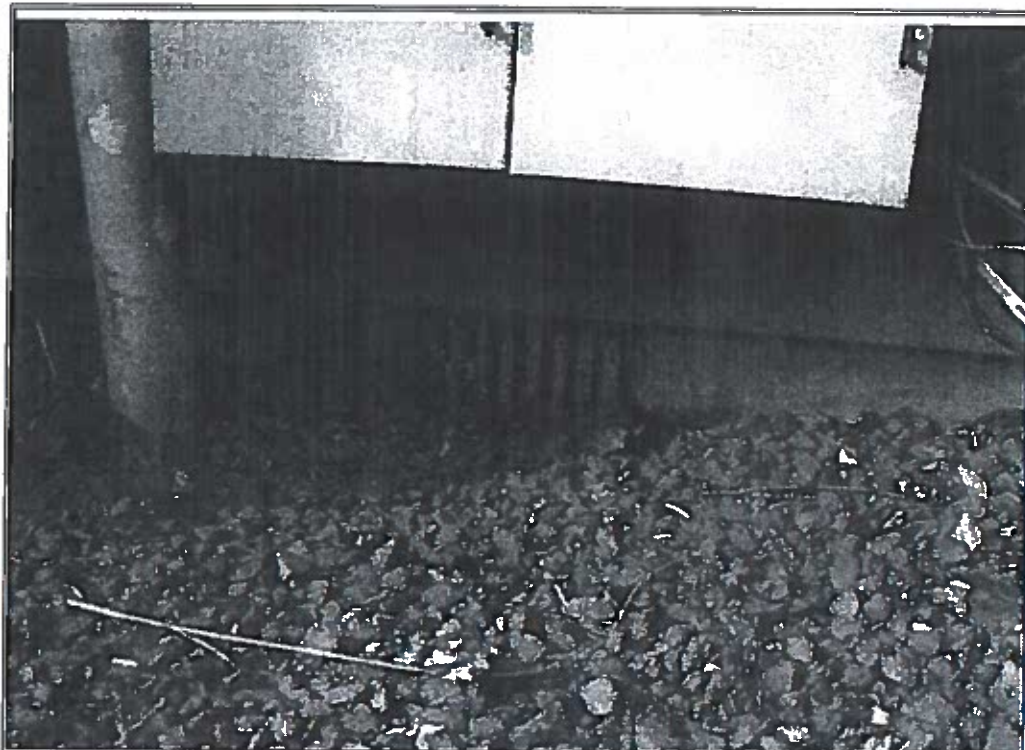
Photo Number
20

Description:
Typical crawlspace
vent partially
covered with
landscaping
material

We recommend periodic preventative maintenance in the crawl spaces such as; maintaining grading away from all of the foundations and opening of all crawl space vents during the summer months. These vents must be kept clear of any landscape materials. We also recommend periodic scraping and painting of any rust on the structural support systems.

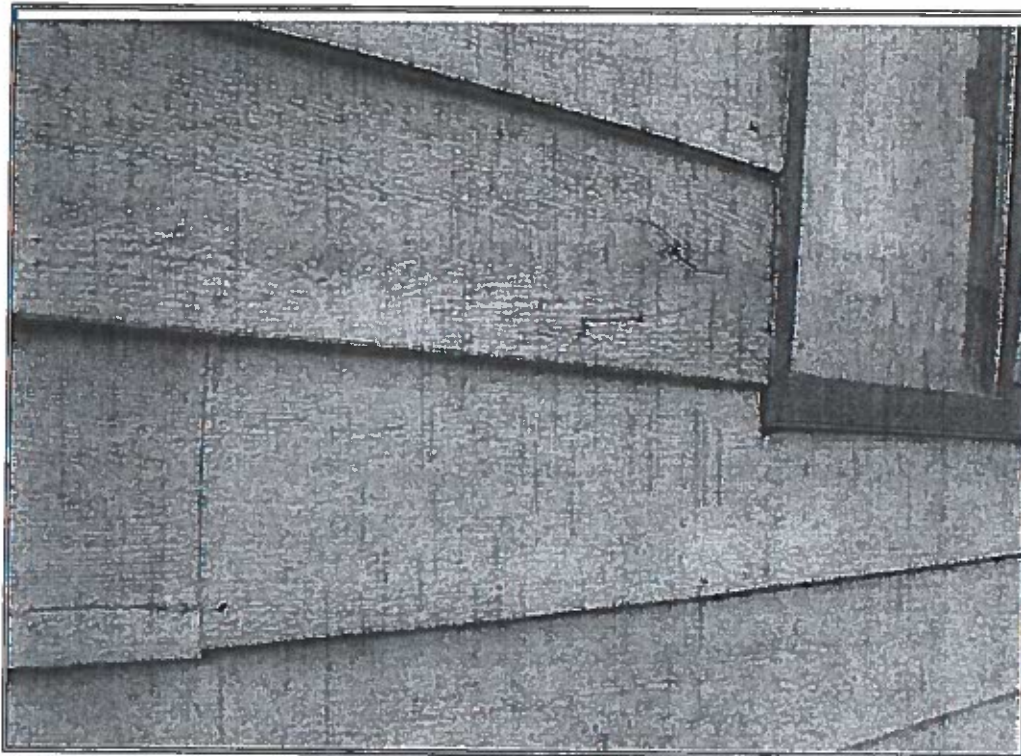
Photo Number
23

The wood board siding is generally in good condition however it appears that some boards have been replaced and/or repaired over the years. This material typically has an EUL of 40 to 50 years. Therefore we recommend that reserve funds be accumulated for the eventual replacement of all of the siding. We have also included periodic painting of the wood siding in the Reserve Tables because it is a large, non-annual expense.

Description:
Close-up of wood
board siding detail
at a typical
window

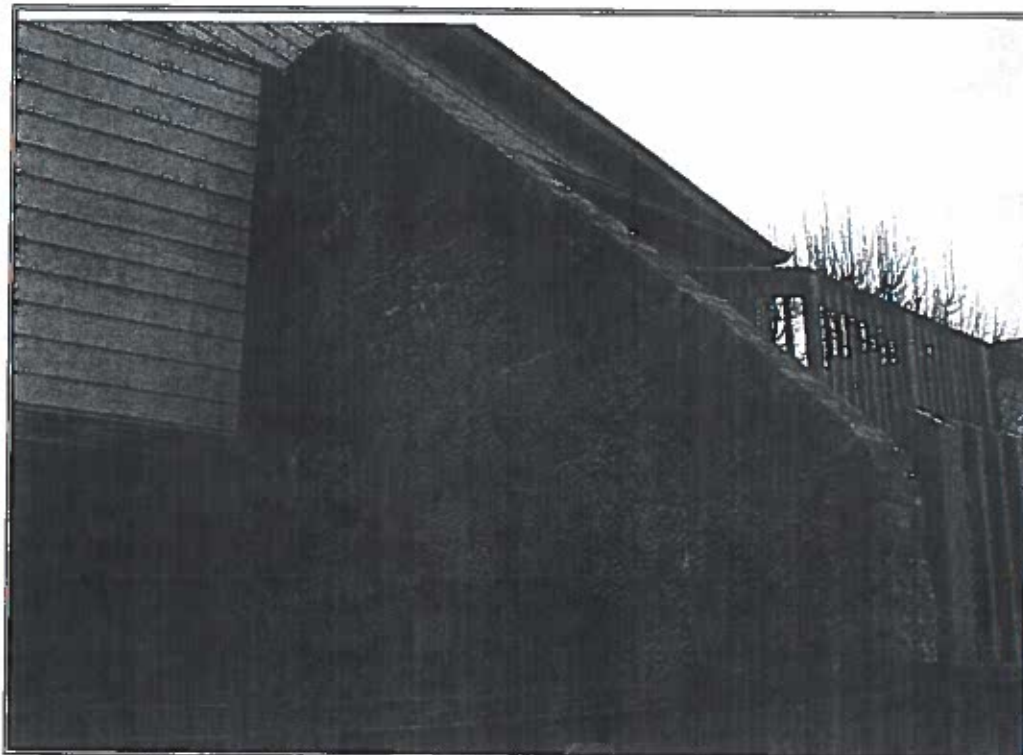
Photo Number
24

The masonry divider walls are generally in good condition. We did not observe any areas of significant cracking or any structural instability. However we recommend that periodic maintenance be performed for these walls including; any minor crack repair, re-parging, or coating of the block surfaces and re-pointing of the brick trim. We have included a cost estimate for this work in the Reserve Tables.

Description:
Typical two-story
exterior masonry
divider wall

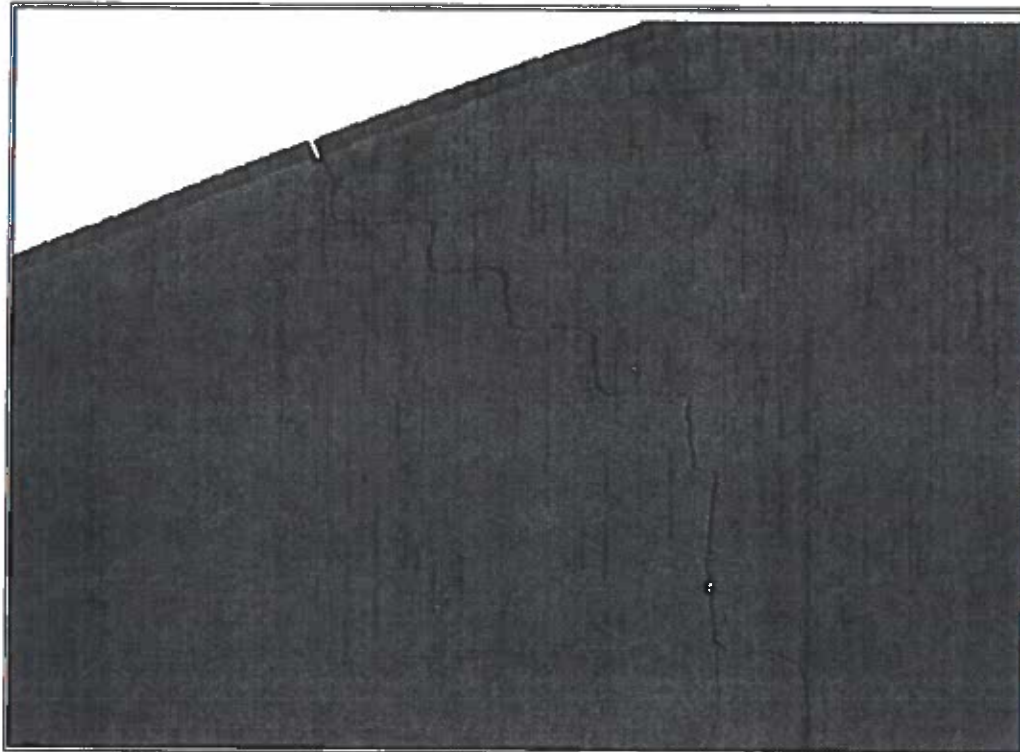
Description:
Cracking in the
masonry sport
court enclosure
wall
